Wheaton Park District

**Wheaton Park District Board of Commissioners
SUBCOMMITTEE MEETING
Wednesday September 7, 2022, 5:00 p.m.
DuPage County Historical Museum
102 E. Wesley Street, Wheaton, IL 60187**

Re: Limited Leak Assessment and Recommendations for Next Steps
Rice Pool Filter Room – Main Roof
1777 South Blanchard
Wheaton, IL 60189
K&H Job No. 09871.0005R

Assessment Report for Exterior Envelope.

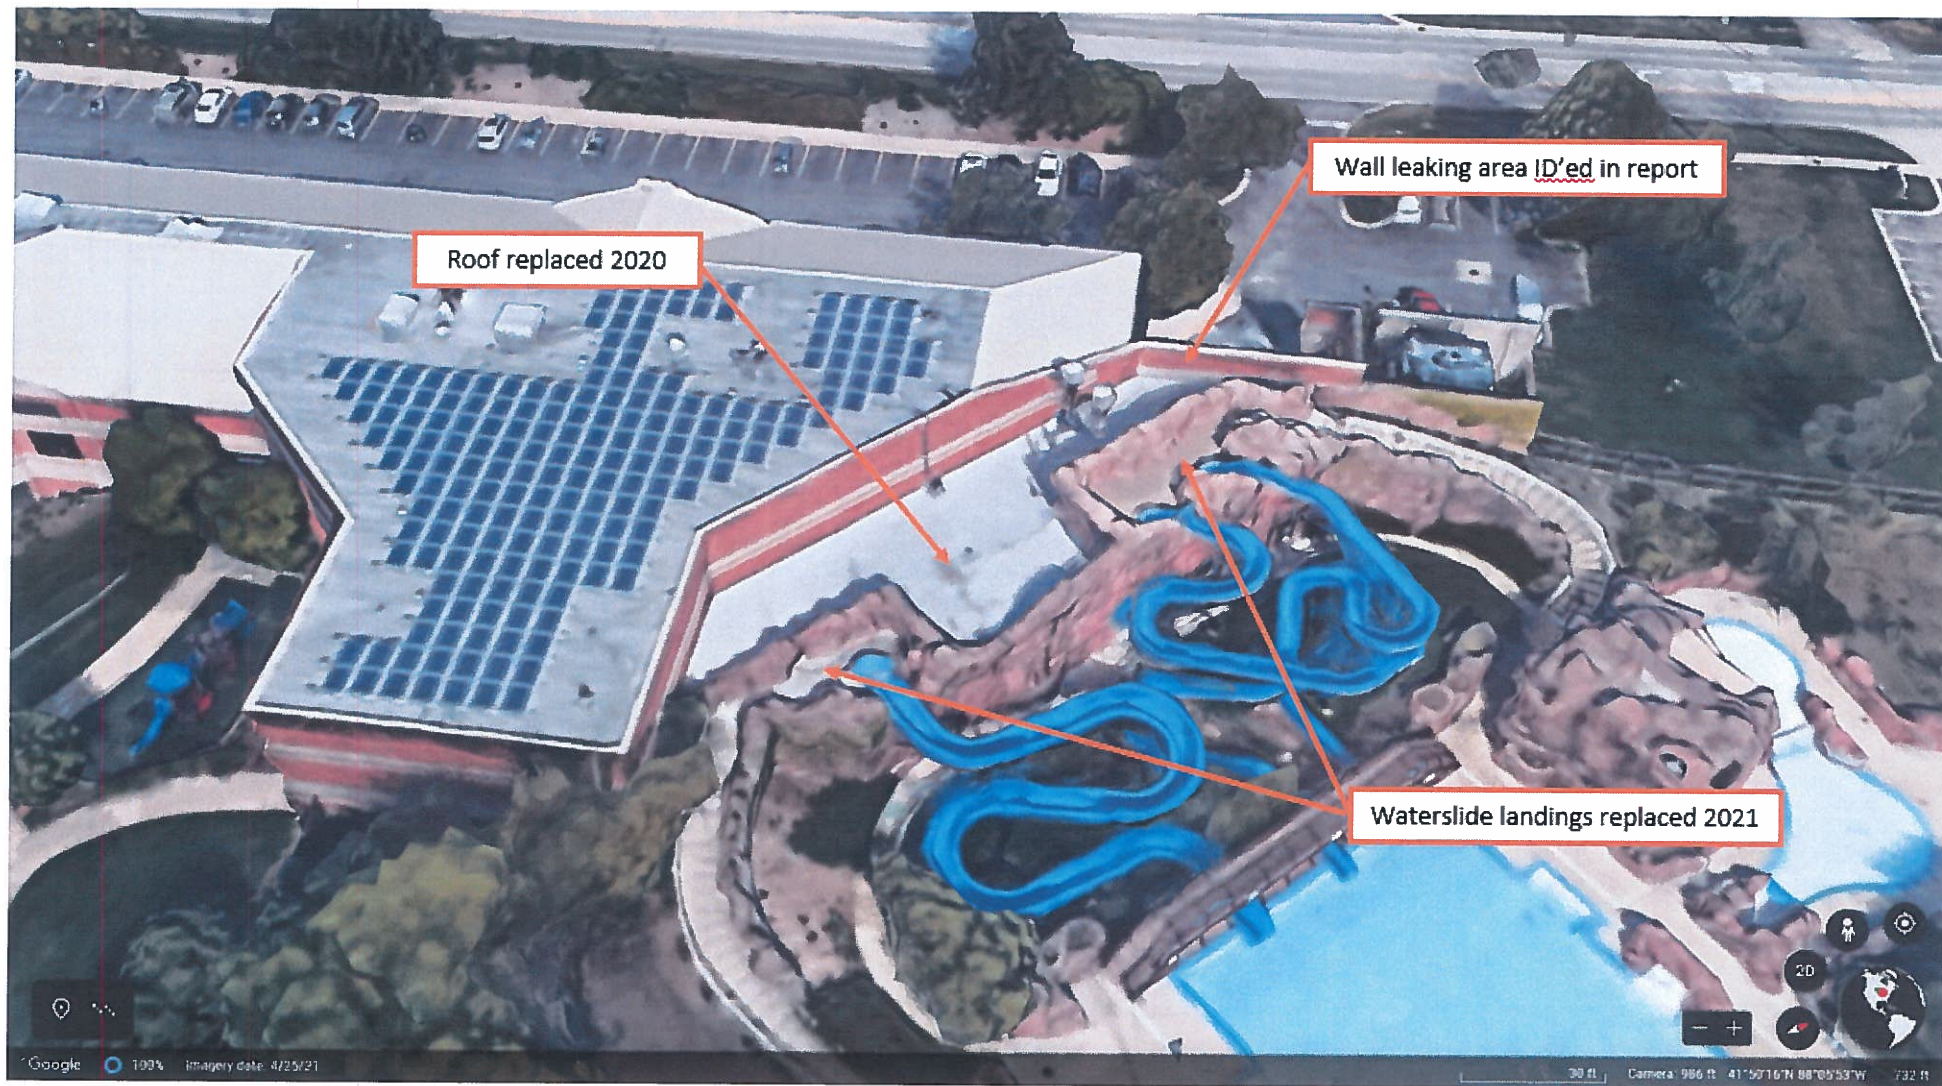
Roof replaced 2020

Wall leaking area ID'ed in report

Waterslide landings replaced 2021

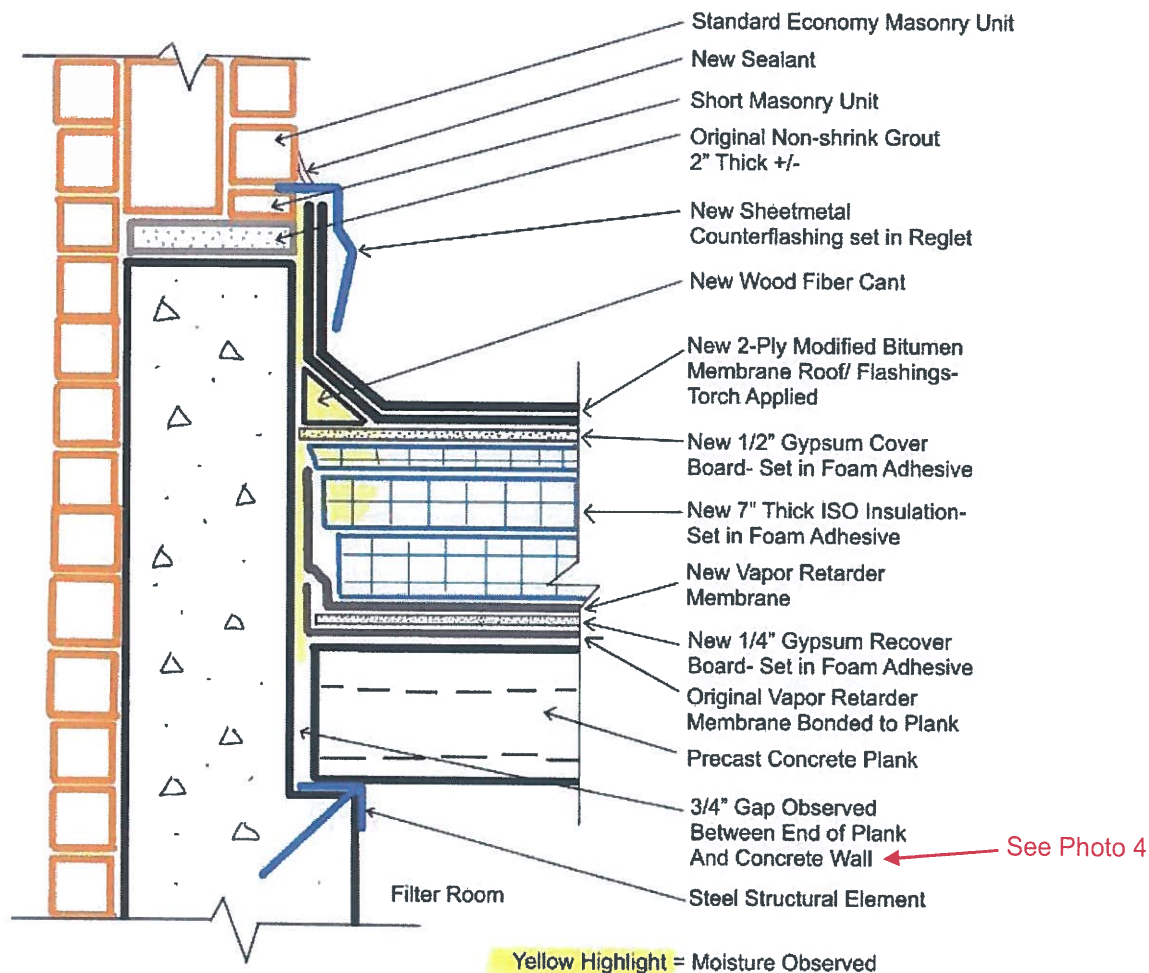
Roof / Wall Interface

During heavy rains (or long periods of rain), the existing wall can become saturated due to existing cracks, condition of mortar, and lack of inter-wall flashings to direct water out. The existing roof system flashings extend above the ledge where non-shrink grout/masonry sits on the wall. Water within the wall appears to be flowing behind roof system flashings and down to a gap between the precast concrete plank (structural roof deck). Water can flow into the filter room at the base of the precast plank and can flow into the voids within the concrete plank. We believe this moisture source is resulting in the moisture that is causing the observed damage to the underside of the concrete planks.

See Figure 1 in the following section.

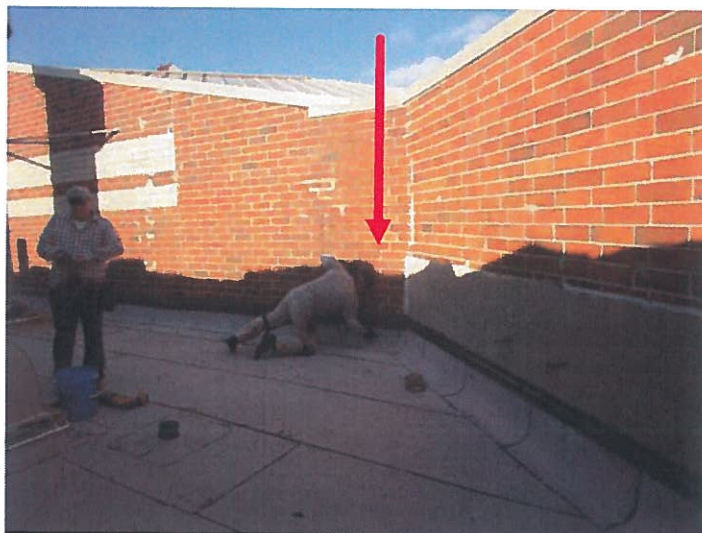
Photo No. 1

West Filter Room Roof Parapet. Area of leak below noted by red arrow.

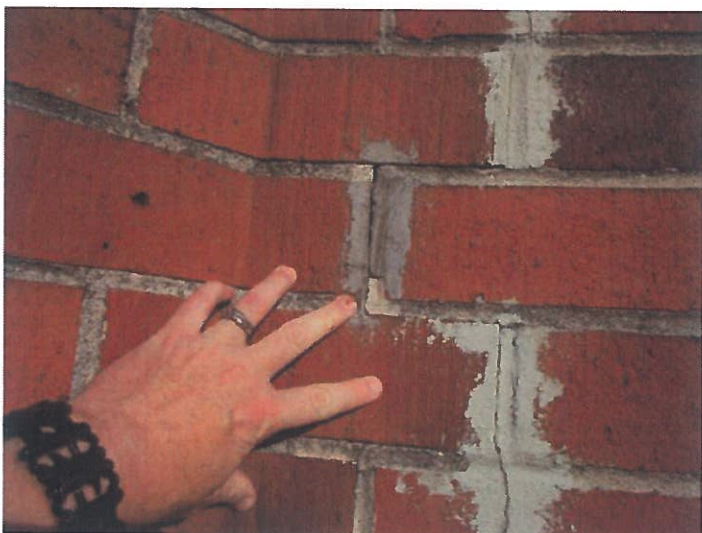
Photo No. 2

Typical cracks/surface defects observed at west parapet wall in the area above the leak below

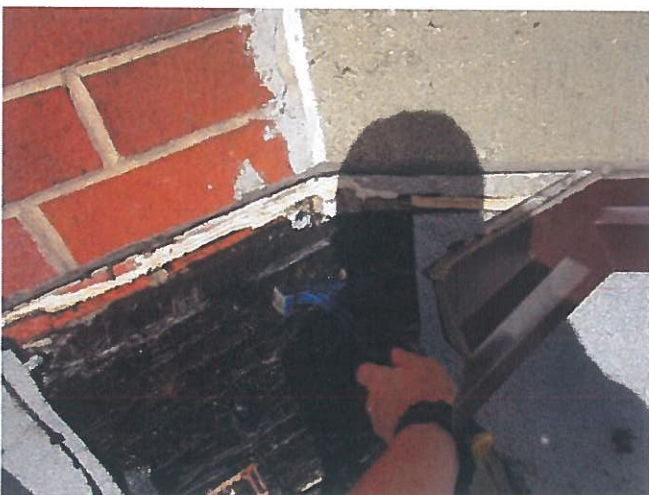
Photo No. 3

Roof Opening Location One. See Figure One.

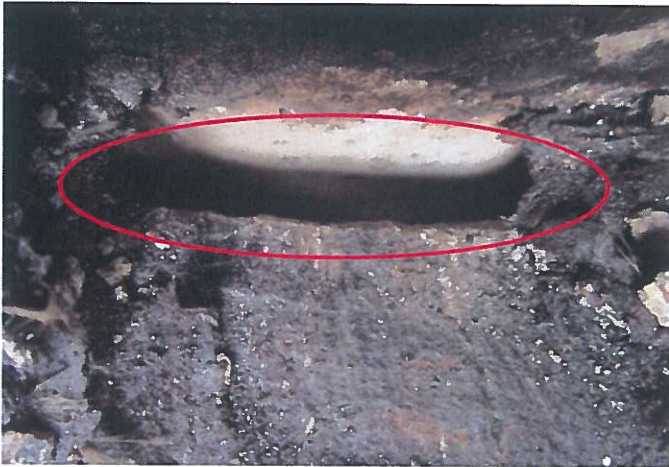
Photo No. 4

Gap between concrete structural wall and precast concrete plank. During conditions where masonry wall components become saturated (like during heavy sustained rains or consecutive days of rain), water entering the masonry wall surface above can bypass roof system flashings and enter this gap and flow down to the concrete plank voids and plank/wall interface below.

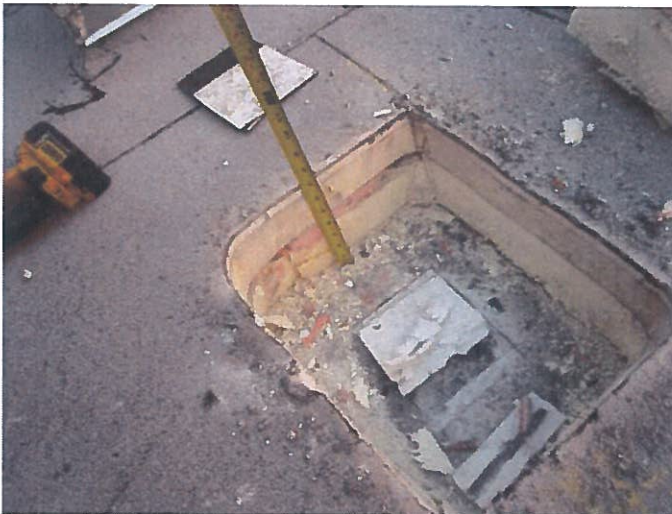
Photo No. 5

Roof opening two – inbound of roof edges. Components found to be dry.

Note, a membrane presumably from a previous roof system was found bonded to the precast concrete plank surface making review of the top plank surface impractical.

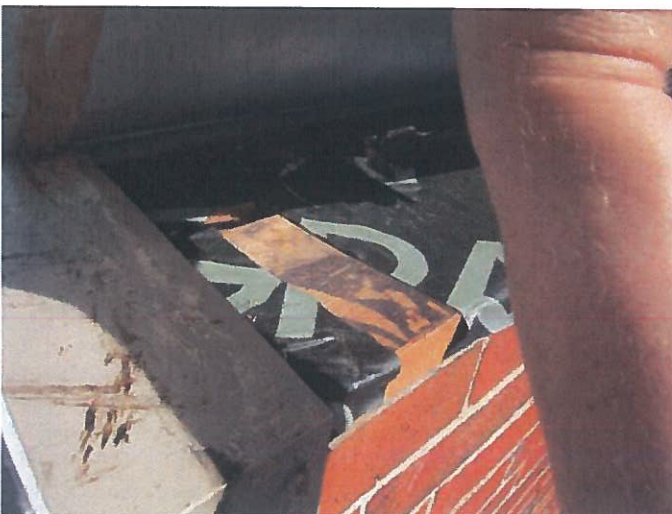
Area below the West Parapet Wall coping. A self-adhering membrane was found over the wall nailer. The membrane was removed to expose 2x wood nailers at each edge of the masonry wall below. The inter-wall components were not visible. The membrane was replaced by the contractor after viewing.

The membrane seems to provide a barrier for water entering through the metal coping from entering the wall below.

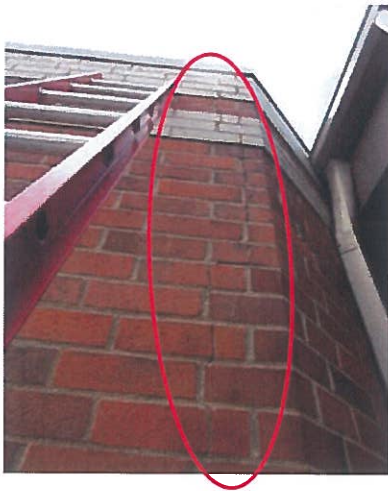
Photo No. 7

Parking-lot side of the West Parapet Wall. Masonry cracks observed in the area noted by the red oval. Cracks are a water infiltration path.

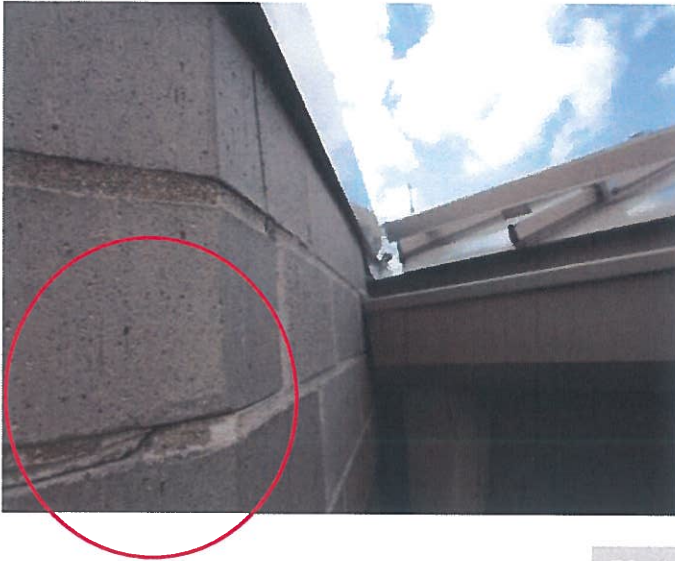
Photo No. 10

Close-up of wall cracks observed.
Adjacent metal roof termination in the background.

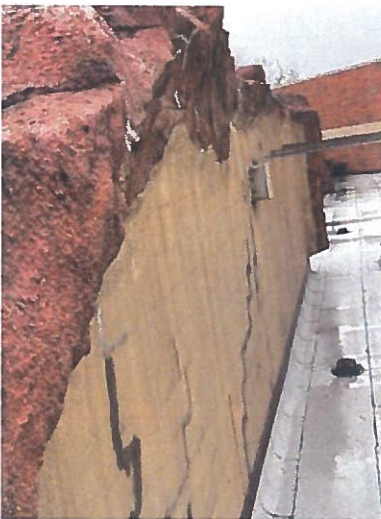
Photo No. 11

Other wall surfaces where the recommend coating could potentially be installed to mitigate water infiltration.

K&H recommends meeting with facility staff ahead of issuing the RFP in order to discuss roof/wall areas where the coating could be beneficial to reduce water infiltration into the building and moisture entering the Filter Room Roof such as coated CMU walls and rockwork walls adjacent to the filter room roof at edges other than the west parapet wall. An RFP could be structured to identify a base area of work to address current water infiltration and other optional areas of application that could be beneficial over the longer term. The goal would be to establish pricing so that the park district could proceed knowing actual pricing that could be used for budgeting. See Photos 11-12.

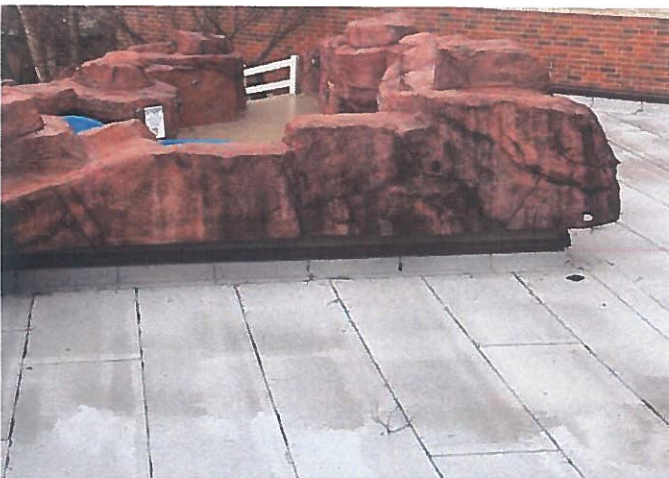
Photo No. 12

Other wall surfaces where the recommend coating could potentially be installed to mitigate water infiltration.

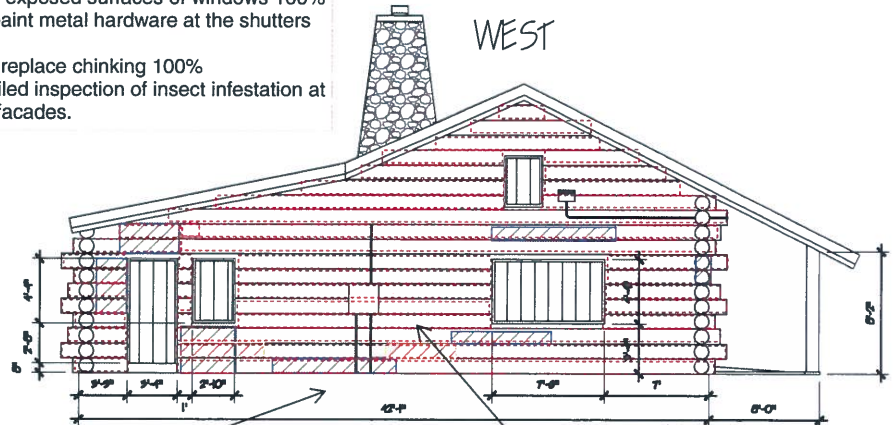
WEST

Hole in landscape along foundation

Evidence of infestation across the entire elevation

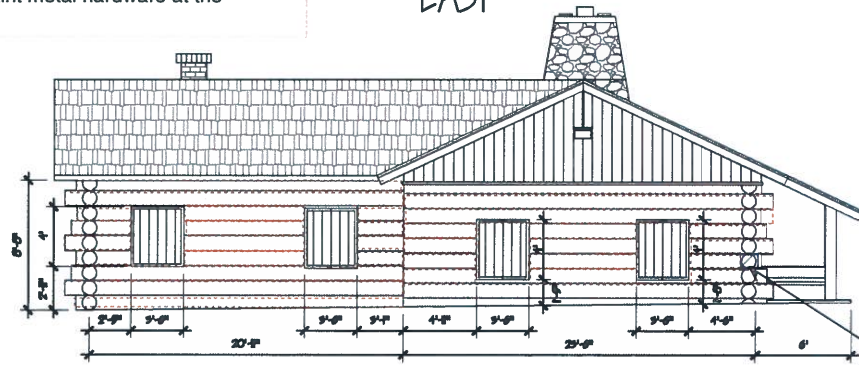
EAST

DAMAGED CROWN
RECOMMEND
REPLACEMENT

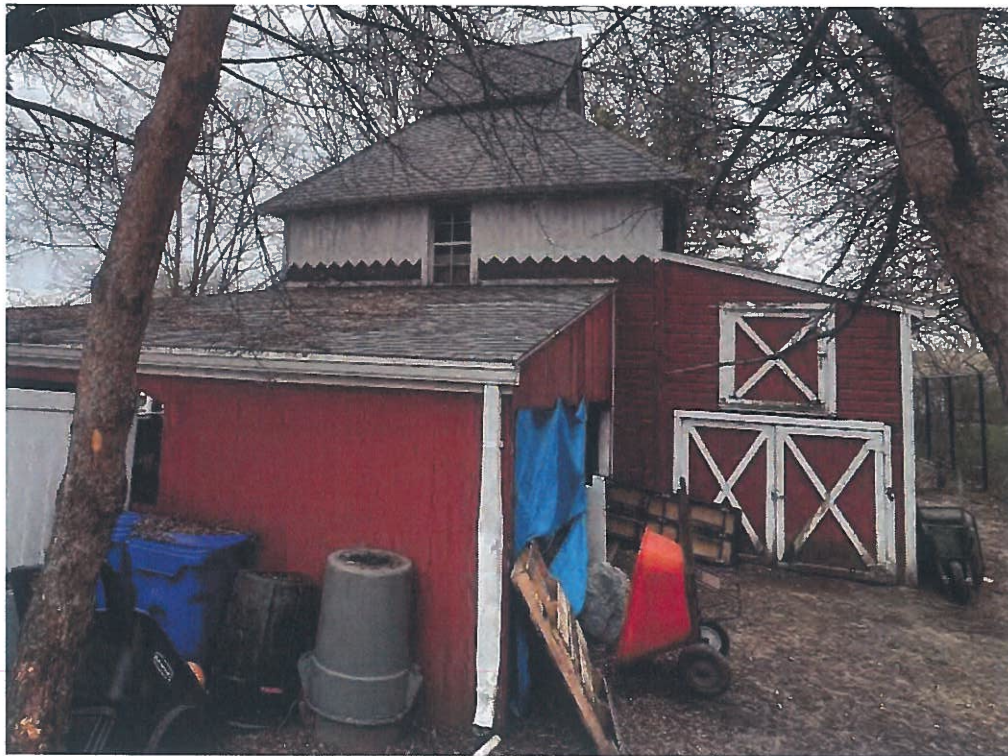
Figure 9. North Elevation. Note the smashed downspout at the lean-to.

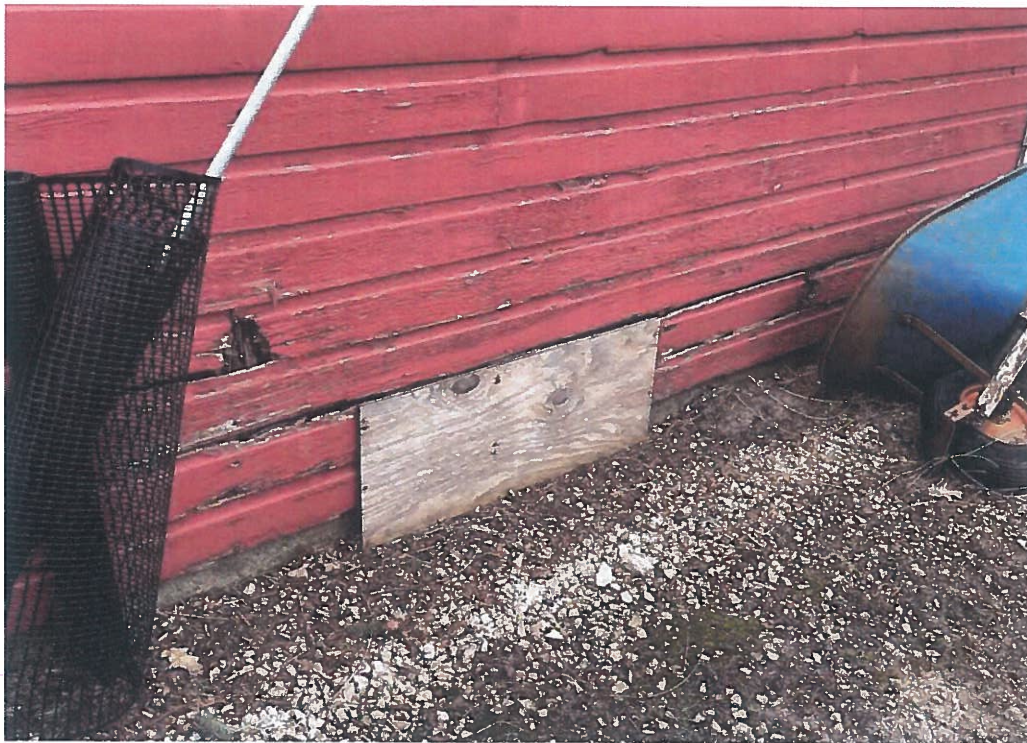
Figure 11. Deteriorated and missing clapboard on the original portion of the barn.

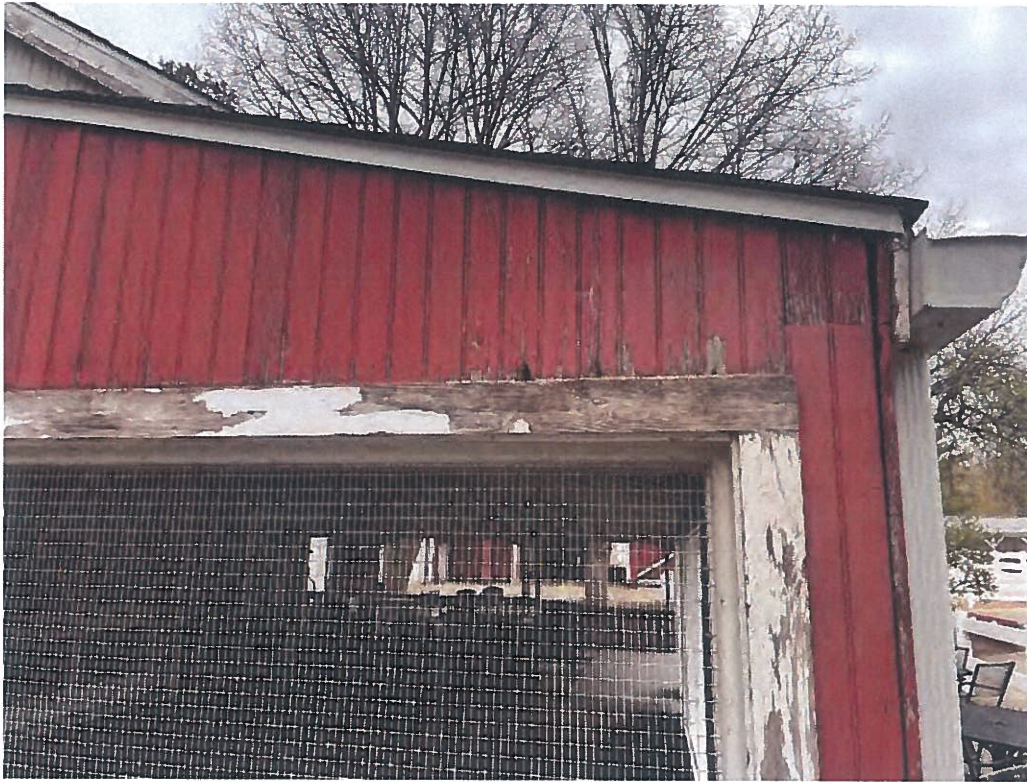
Figure 12. Deterioration at the wood clapboards and frame of the opening at south elevation

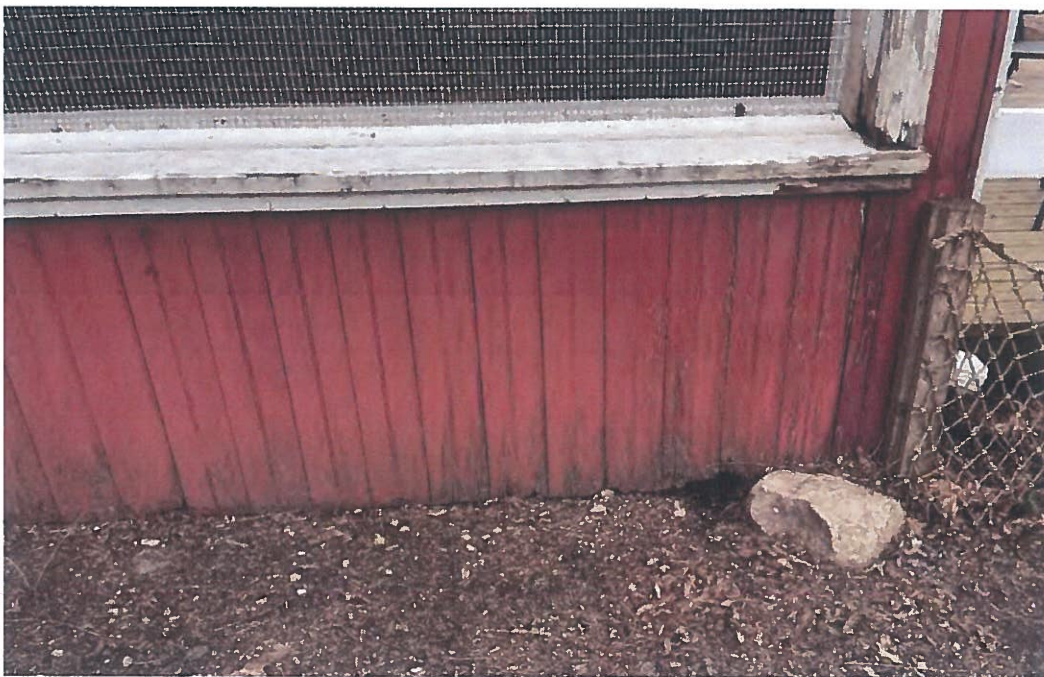
Figure 13. Deterioration of clapboards at the base of the structure

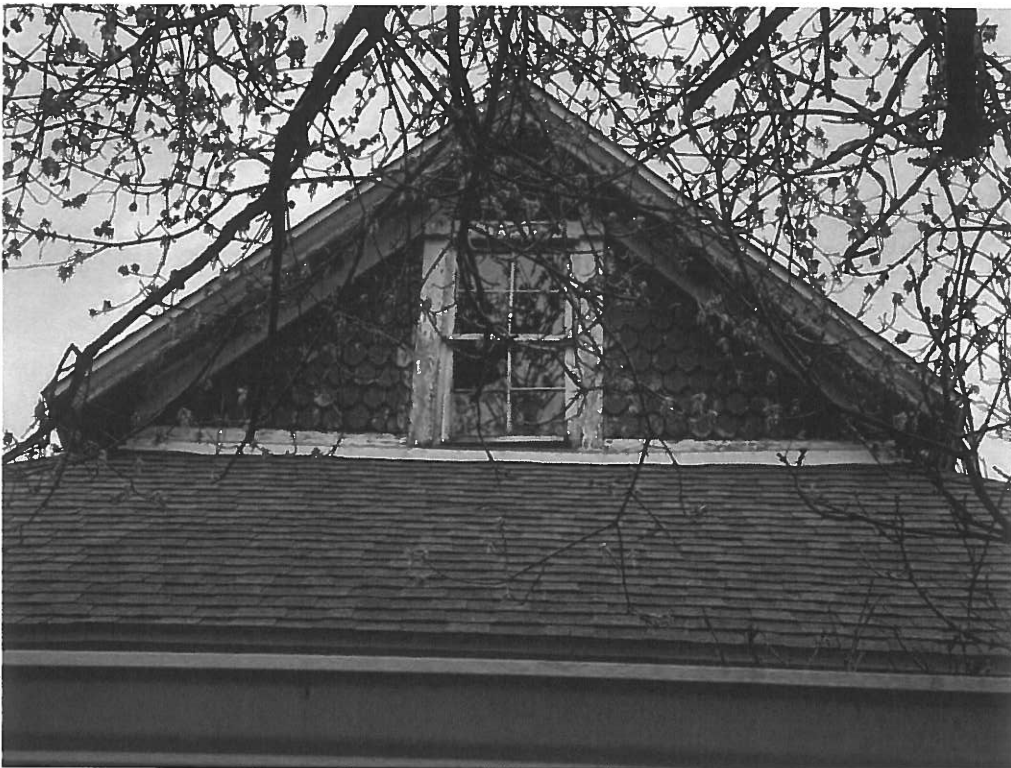
Figure 15. Upper portion of the west elevation. Note broken windowpane.

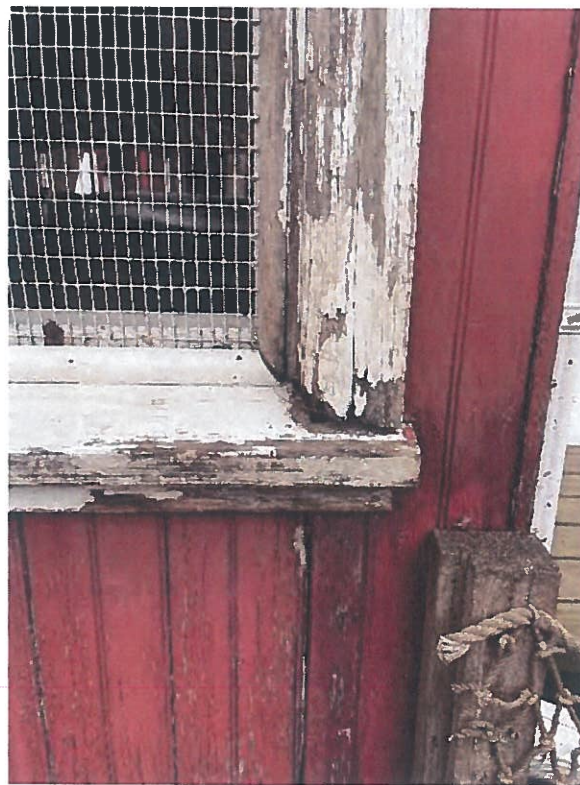
Figure 17. Deterioration at corner of opening on the south elevation

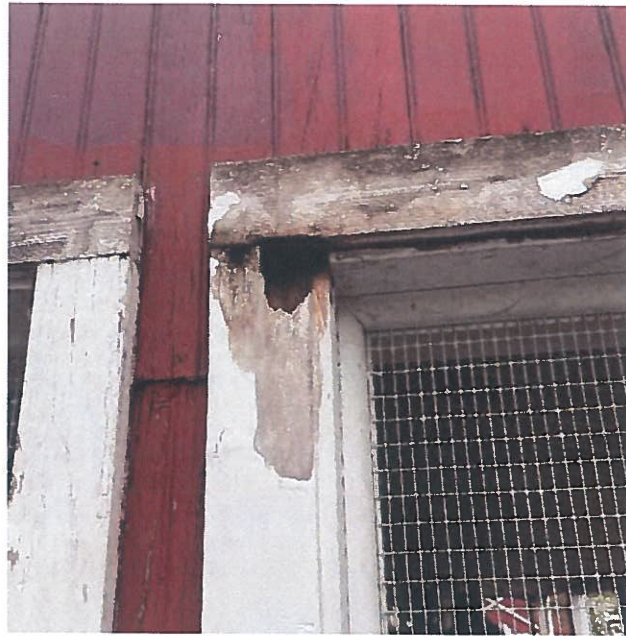
Figure 18. Damage at the frame of the opening

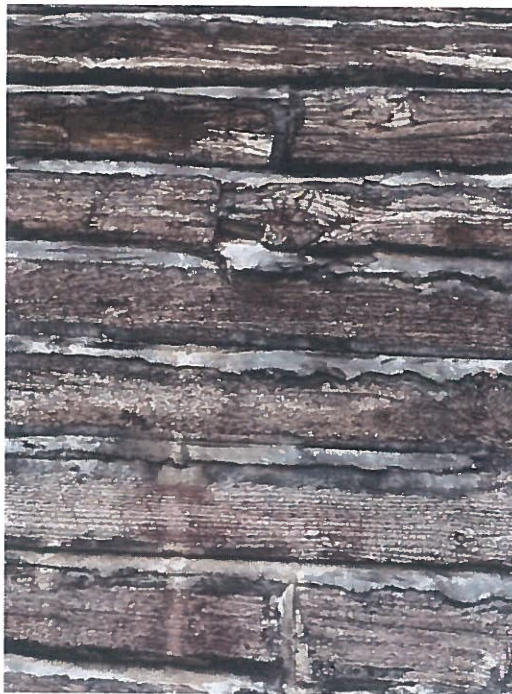
Figure 27. Wood log conditions at the Boy Scout Cabin

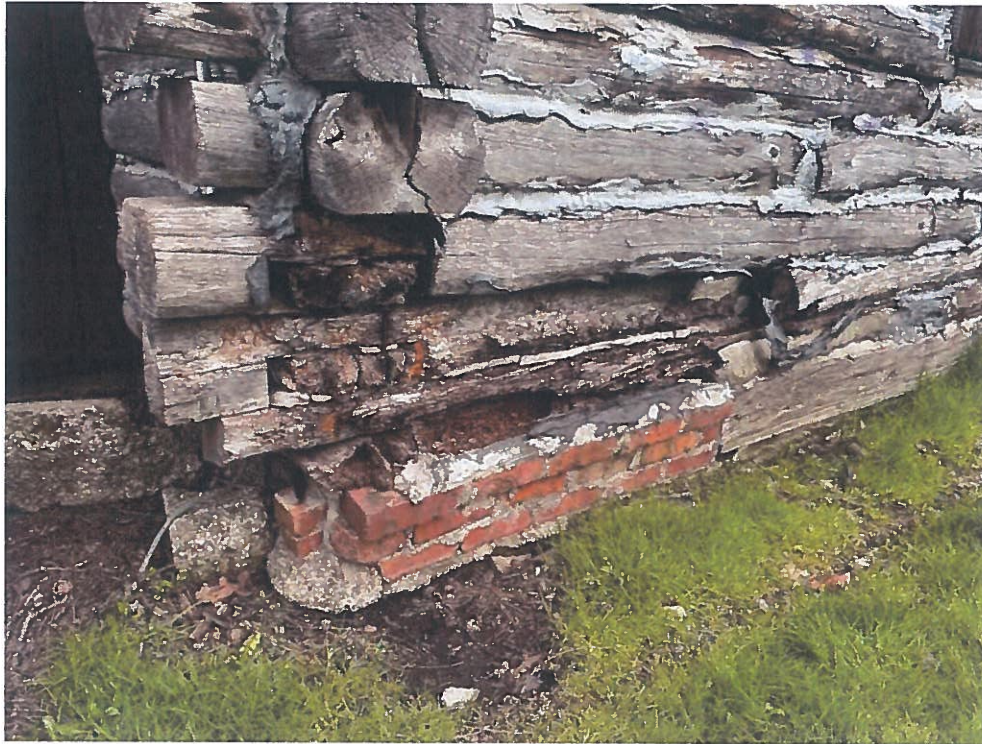
Figure 32. Deterioration of Wood logs at corner notching

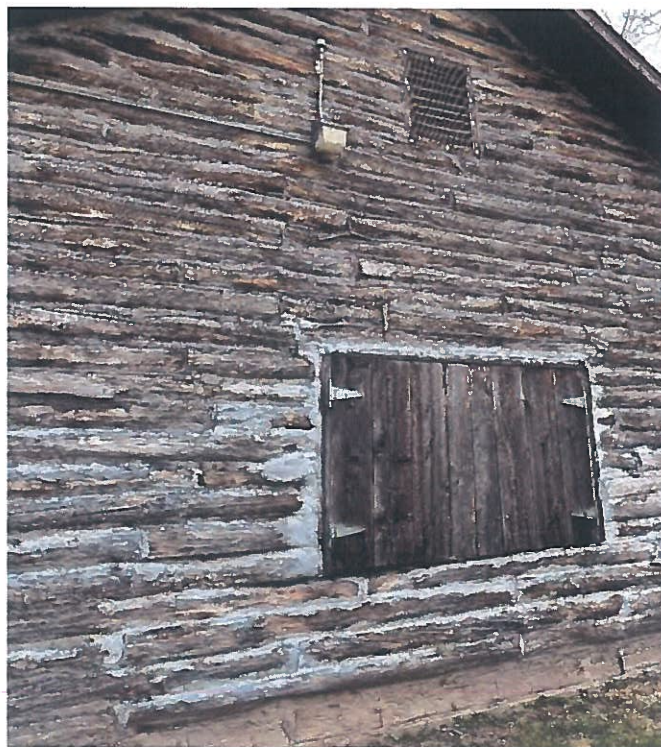
Figure 33. Mastic material at east elevation

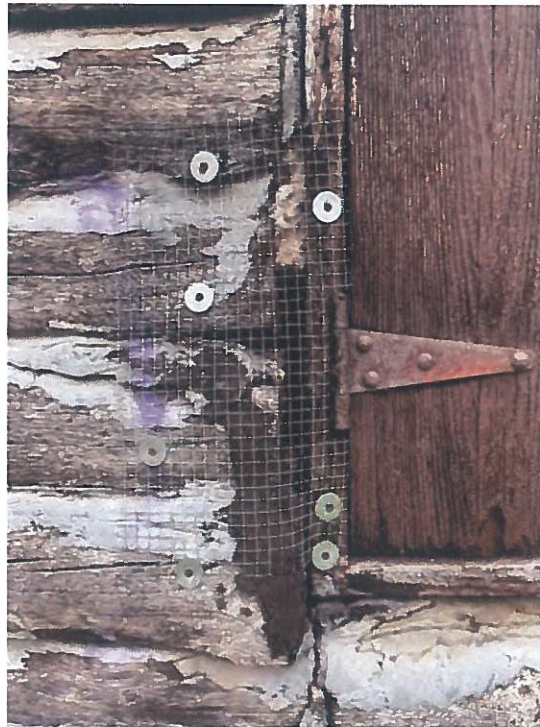
Figure 34. Hole adjacent to Window frame and damaged wood

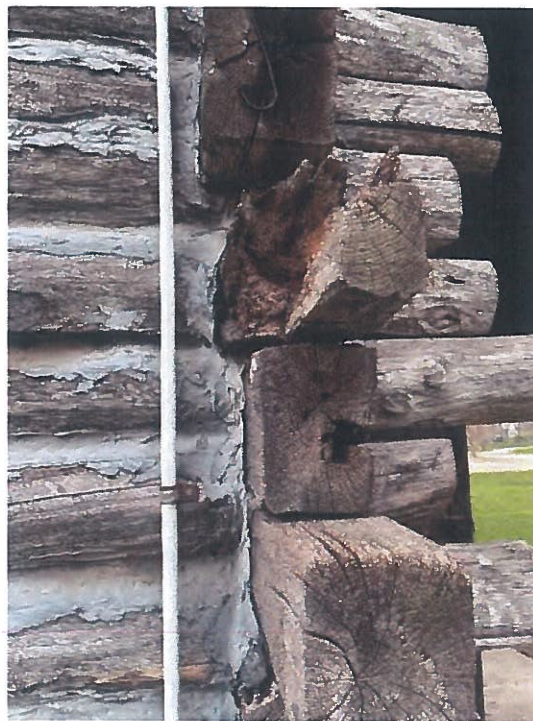
Figure 35. Broken wood log at notching

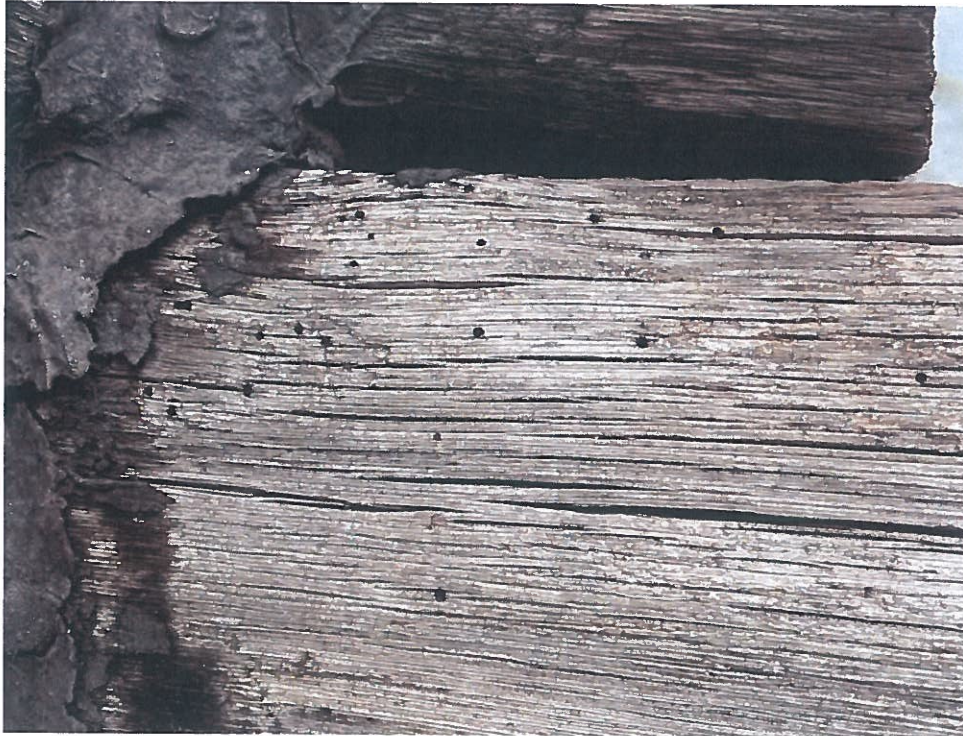
Figure 36. Infestation and woodpecker damage at west elevation

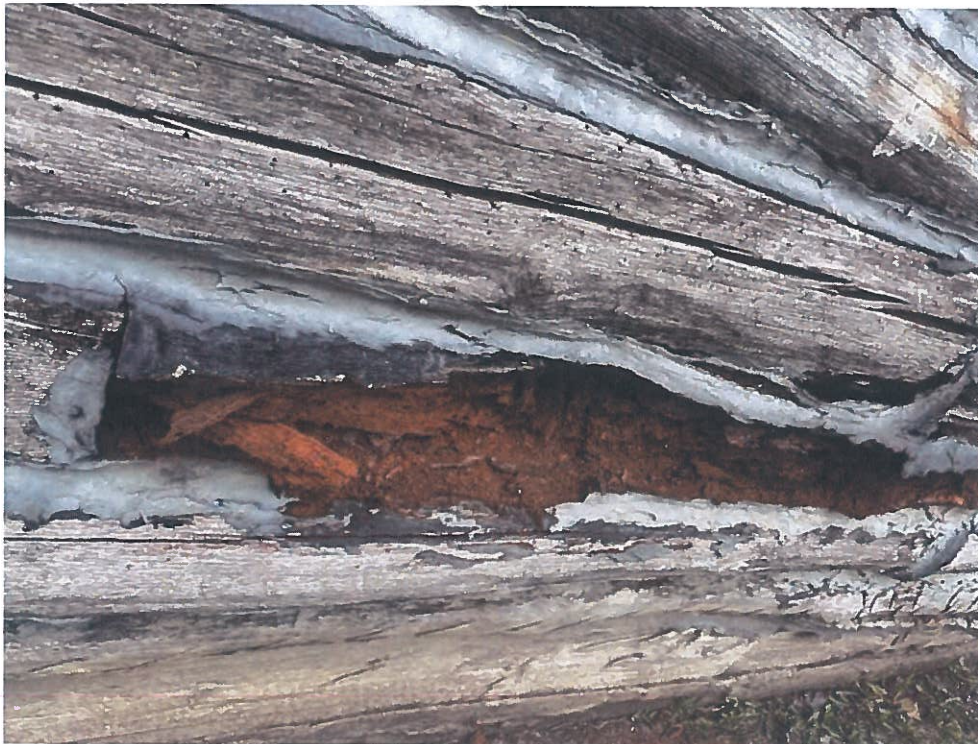
Figure 37. Infestation at west façade

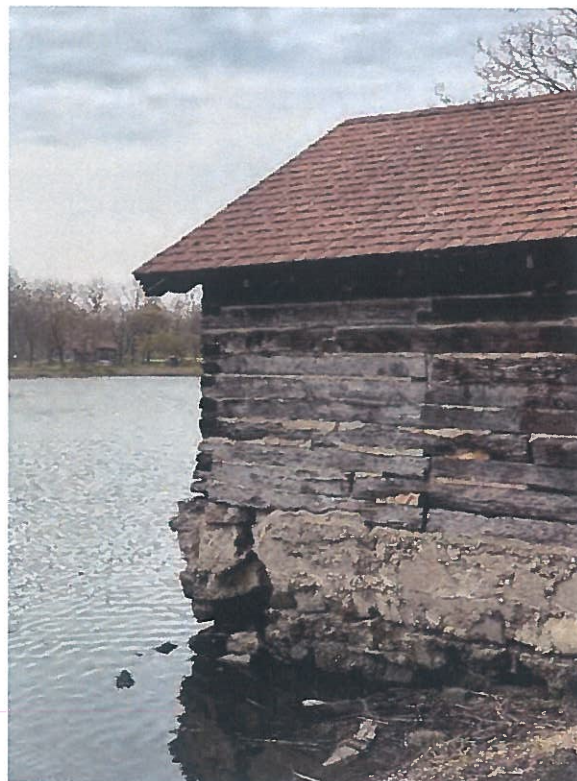
Figure 43. Cracked foundation in critical condition at southwest corner

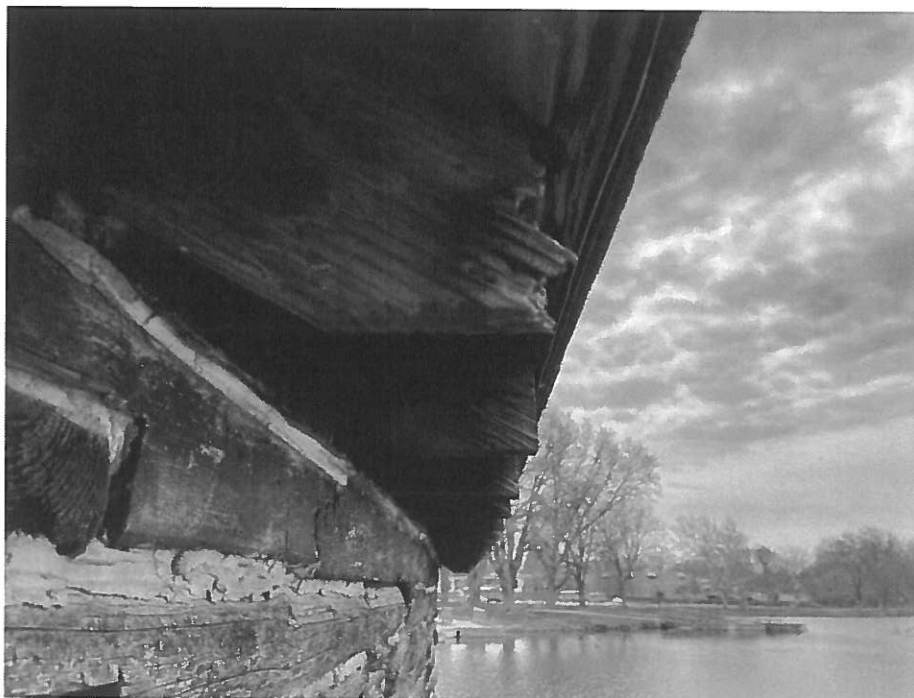
Figure 44. Chipping wood rafters

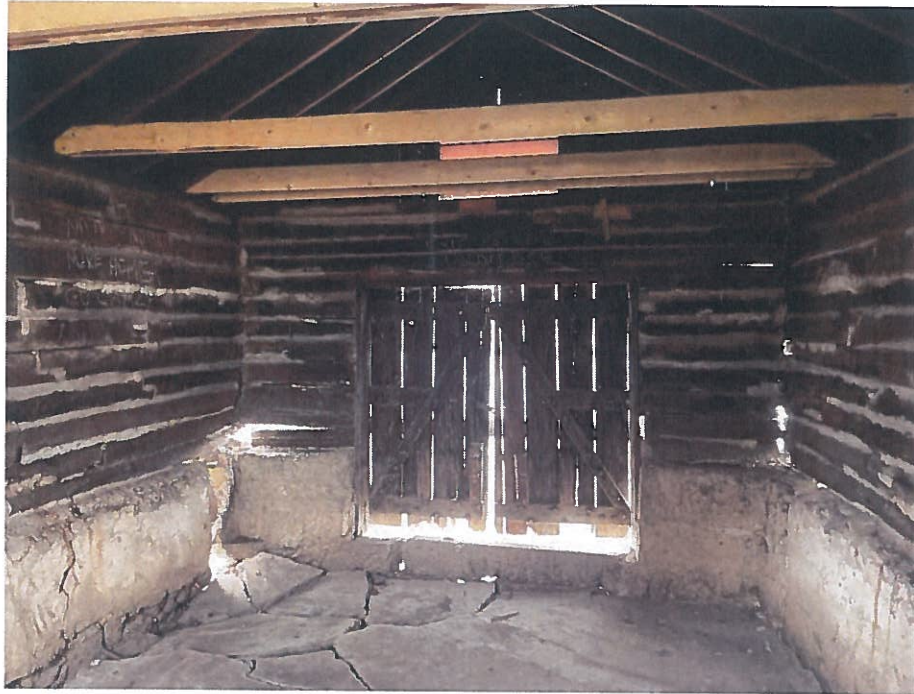
Figure 46. Cracked concrete floor and door on the West elevation

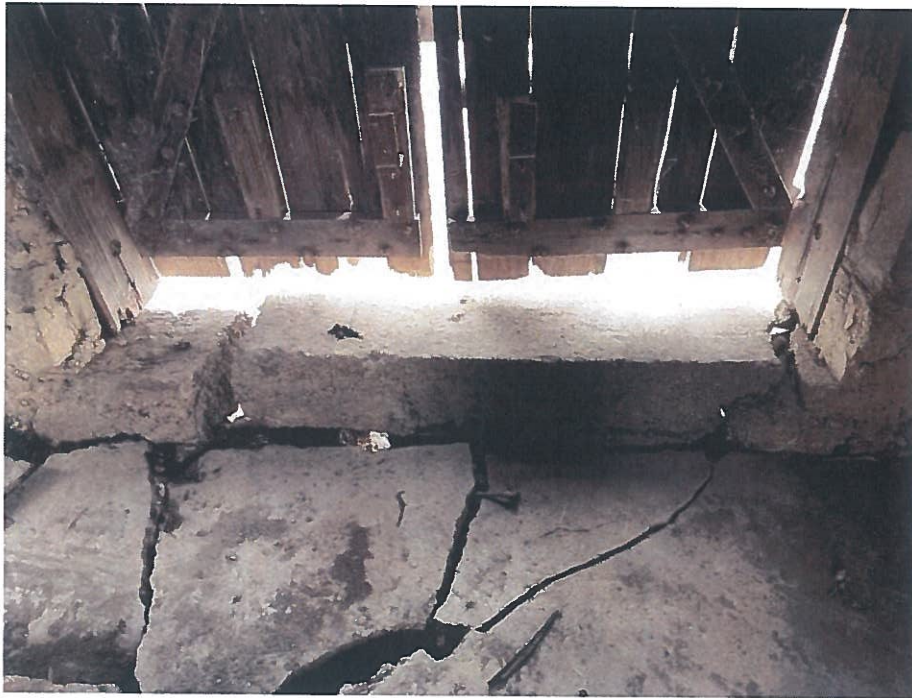
Figure 47. Cracked concrete floor near door on west façade

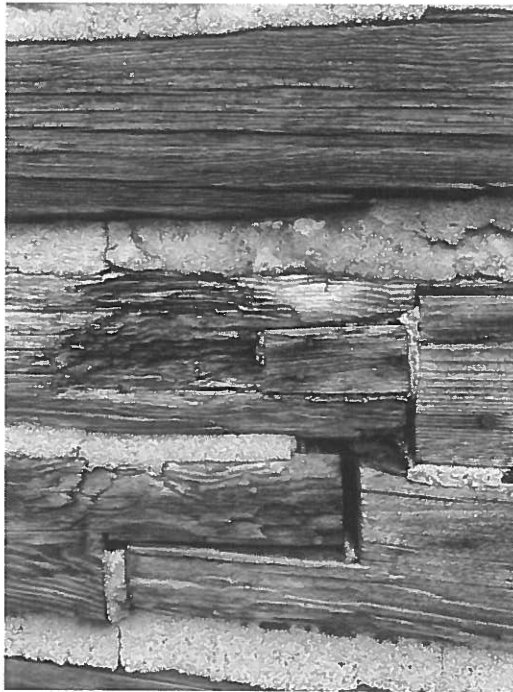
Figure 48. Splitting wood logs

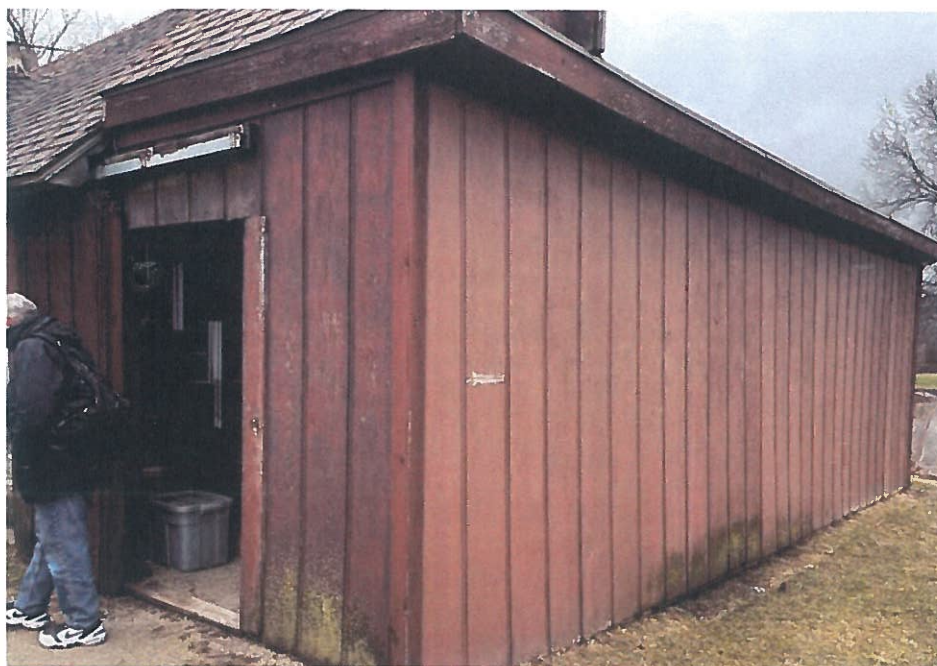
Figure 52. Deteriorated wood boards at addition of Woodshop

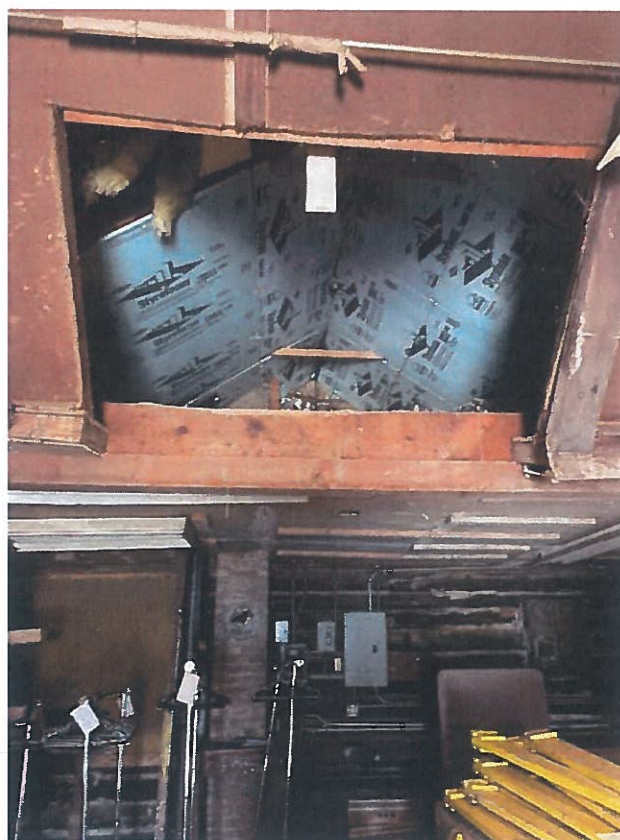
Figure 53. Bowing ceiling

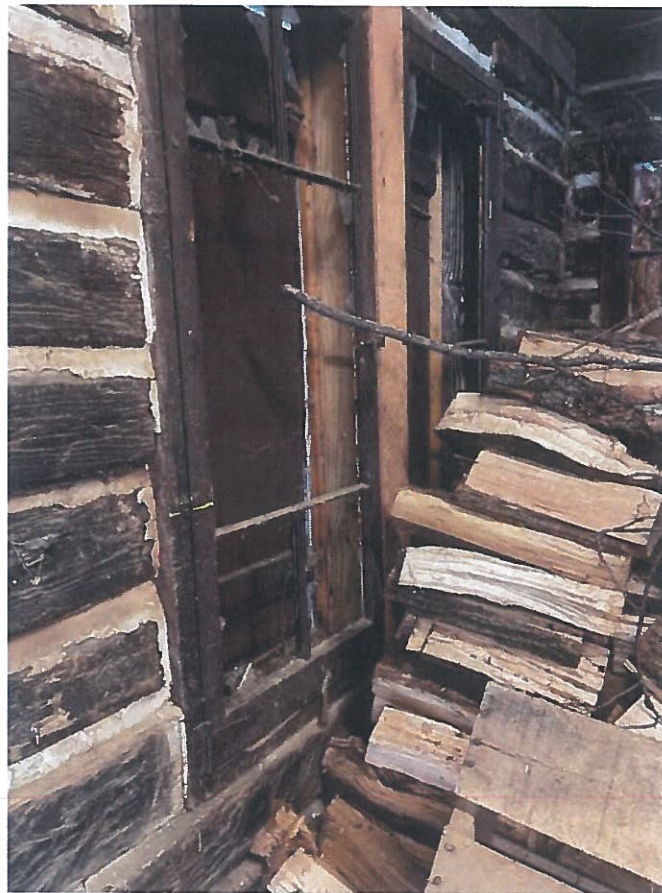
Figure 55. Broken windowpanes at the Woodshop
