Wheaton Park District

**Wheaton Park District Board of Commissioners
SUBCOMMITTEE MEETING
Wednesday September 7, 2022, 5:00 p.m.
DuPage County Historical Museum
102 E. Wesley Street, Wheaton, IL 60187**

Re: Limited Leak Assessment and Recommendations for Next Steps
Rice Pool Filter Room – Main Roof
1777 South Blanchard
Wheaton, IL 60189
K&H Job No. 09871.0005R

Assessment Report for Exterior Envelope.

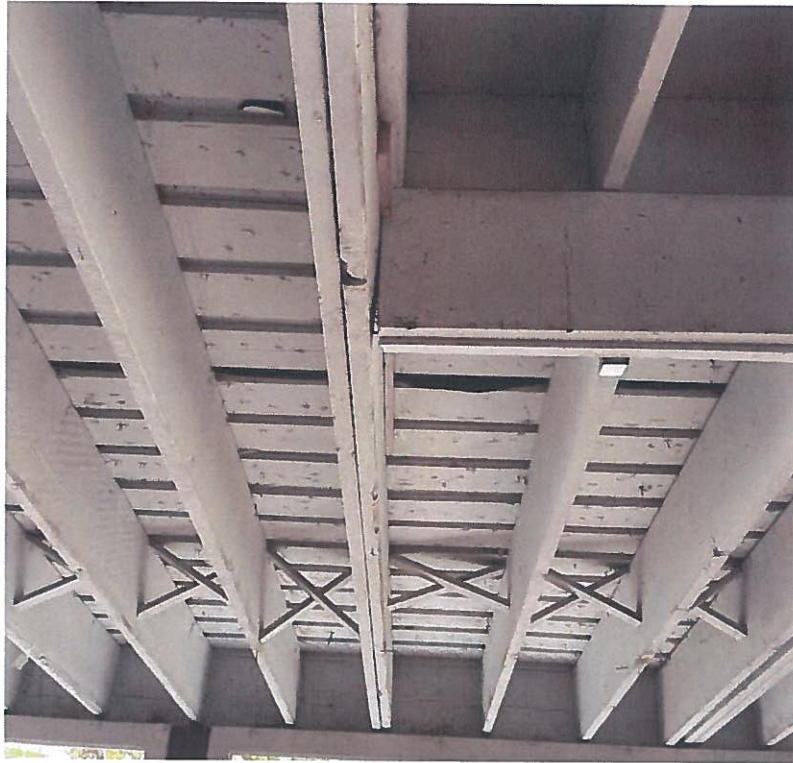
Figure 20. Underside framing at the cover porch

The walls and roof line are primarily plumb and true however, some of the nailed connections at the ridge rafters and framing below the hayloft chute are separating as discussed above and repaired per Exhibit C, initial assessment. (Figure 19 & Figure 20). Limited areas of sagging of the covered porch roof were also observed at this assessment. The second story of this building is inaccessible and unstable due to structural damage. (Figure 21)
