Wheaton Park District

**Wheaton Park District Board of Commissioners
SUBCOMMITTEE MEETING
Wednesday September 7, 2022, 5:00 p.m.
DuPage County Historical Museum
102 E. Wesley Street, Wheaton, IL 60187**

Re: Limited Leak Assessment and Recommendations for Next Steps
Rice Pool Filter Room – Main Roof
1777 South Blanchard
Wheaton, IL 60189
K&H Job No. 09871.0005R

Assessment Report for Exterior Envelope.

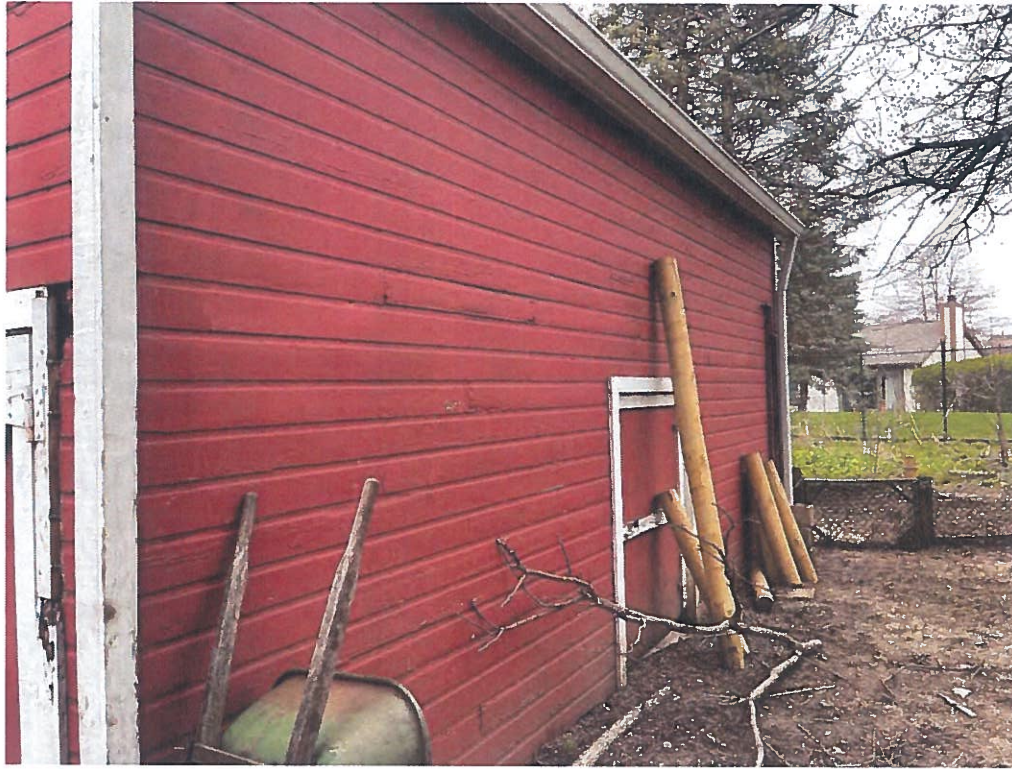
Figure 10. West elevation of the lean-to addition

and the additions have wood flooring. The barn is 2 stories with both the 1st floor and hayloft (2nd floor) acting as storage. The walls are clad in wood shiplap clapboard and vertical plank siding. The additions are clad in vertical bead board. The main roof of the barn is a hip roof with a cross gable and two low slung lean-to roofs. There is a cupola atop of the main roof and windows puncture the gabled end roofs at both the east and west elevations (Figure 1). There is a "dormer" off the east side of the main roof with windows on its north and south elevations, presumably this dormer would have been open to below and could have been used as a hay chute (Figure 6). All roof areas are covered with asphalt shingles. The majority of the windows are double hung wood windows. On the second floor, there is a leaded window on the south portion of the east elevation. There are framed openings on all 3 sides (North, South, and East) of the east porch with wire screens inset in the south openings (Figure 8). The east elevation of the original barn has a large sliding barn door that is rarely used. Next to the main barn door there is a rolling barn door on the north lean-to addition. (Figure 7) There are solid wood double swing doors on the west lean-to with an additional wood swing door above the double door. (Figure 9) There is another door on the west elevations of the lean-to (Figure 10).

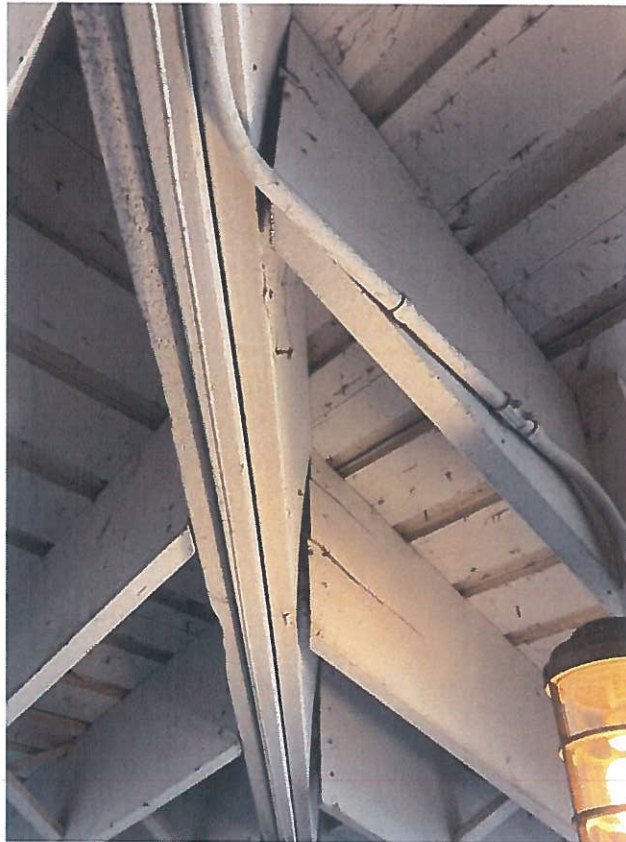
Figure 19. Framing at the underside of the cover porch.

The walls and roof line are primarily plumb and true however, some of the nailed connections at the ridge rafters and framing below the hayloft chute are separating as discussed above and repaired per Exhibit C, initial assessment. (Figure 19 & Figure 20). Limited areas of sagging of the covered porch roof were also observed at this assessment. The second story of this building is inaccessible and unstable due to structural damage. (Figure 21)

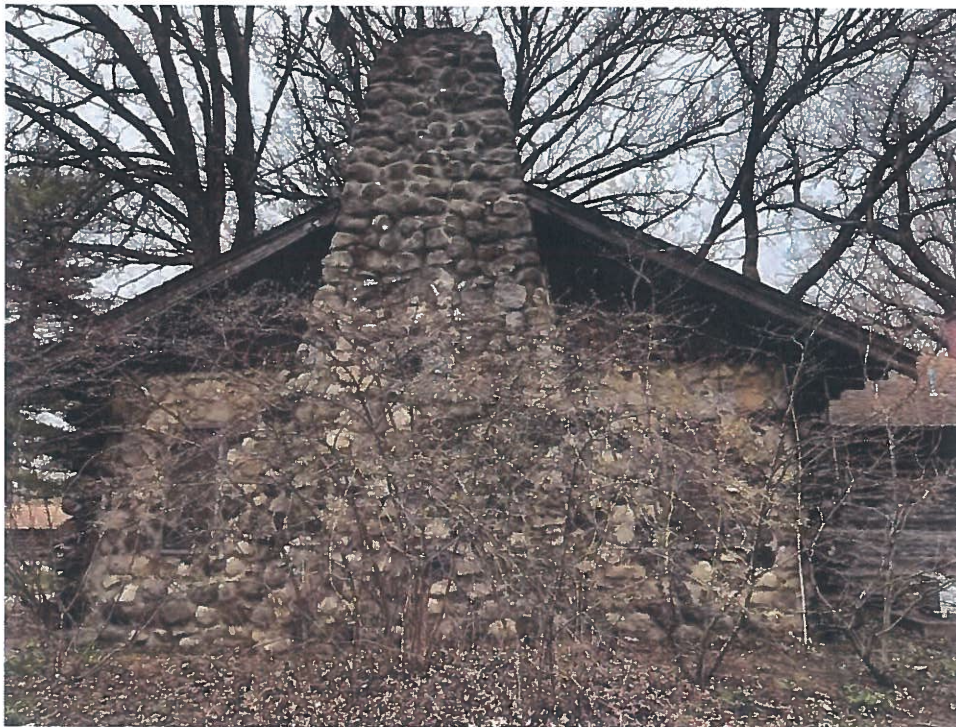
Figure 25. West Elevation of the Boy Scout Cabin

The original cabin has a rectangular plan with saddle corner notching. An addition off the south façade is composed of wood logs with square corner notch, the date of the addition is unknown. The original west façade is composed of stone wall flanked by logs on the adjacent north and south sides. (Figure 25) The stone chimney is also located on the center of the stone façade. The main entrance is at the north façade through a small, roofed porch with one secondary entrance at the south façade. (Figure 2 & Figure 23) There is a second chimney at the addition. The multipaned casement windows are protected with plank shutters. (Figure 26) The cabin has a cross gable roof with asphalt shingles. There is vertical wood planking at the gable ends of the roof.

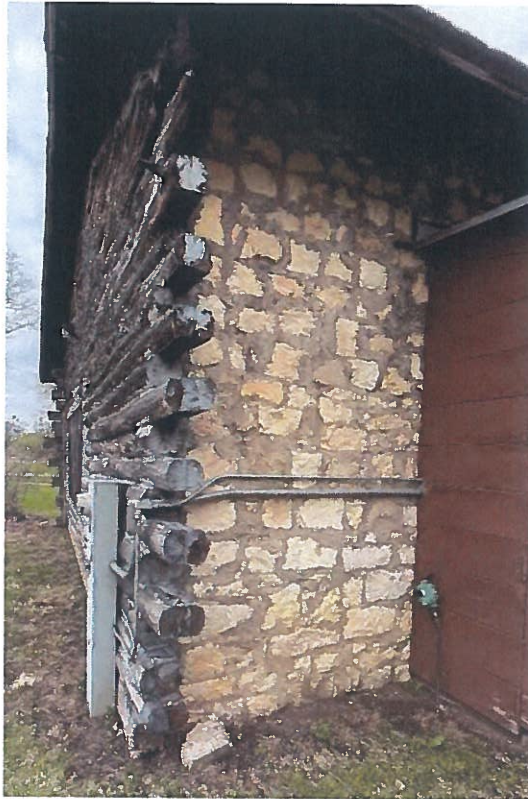
Figure 28. The stone portion of the north elevation.

The limestone stone wall at the north elevation has flush pointed joints instead of having the deteriorated mortar removed and replaced. Cracks and spalls at limited stones have been covered with mortar. (Figure 28) The stone chimney appears to be in similar condition.

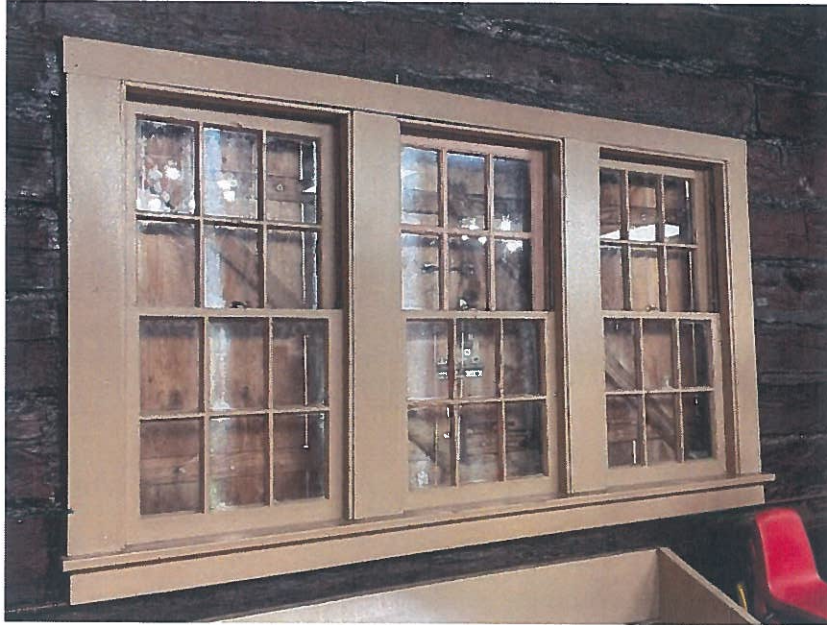
The six over six double hung wood windows are in good condition due to the presence of operable protective wooden shutters. (Figure 38 & Figure 39) There is peeling paint at the window sashes. The doors are in fair condition.

Figure 38. Double-hung windows at the Girl Scout Cabin protected by wood boards from the outside

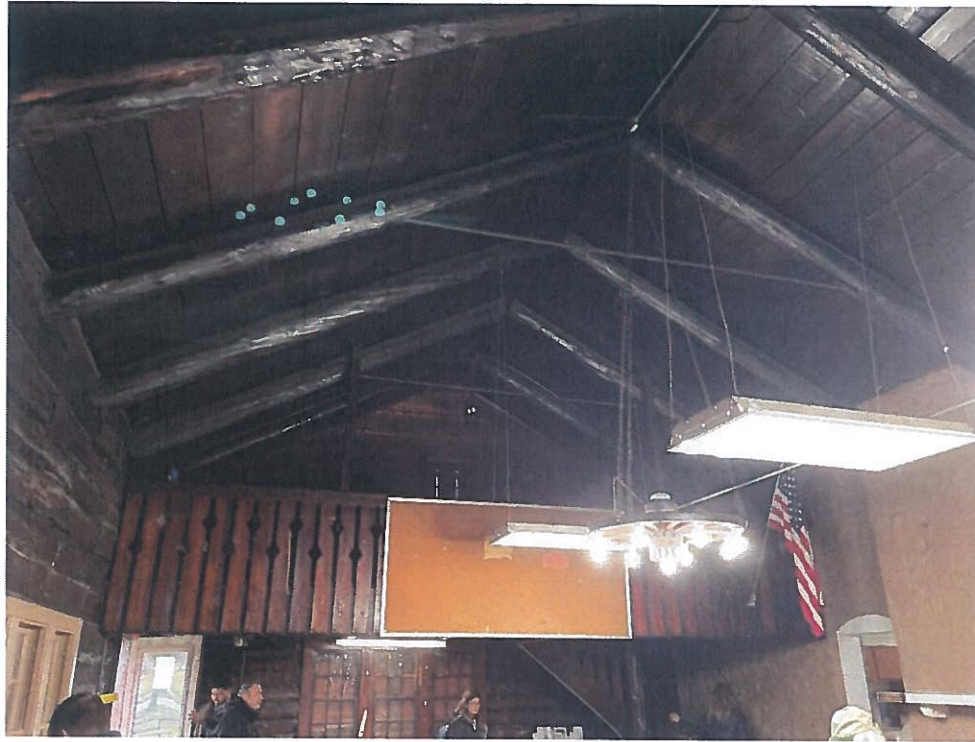
Figure 40. Mezzanine balcony in the girl scout cabin.

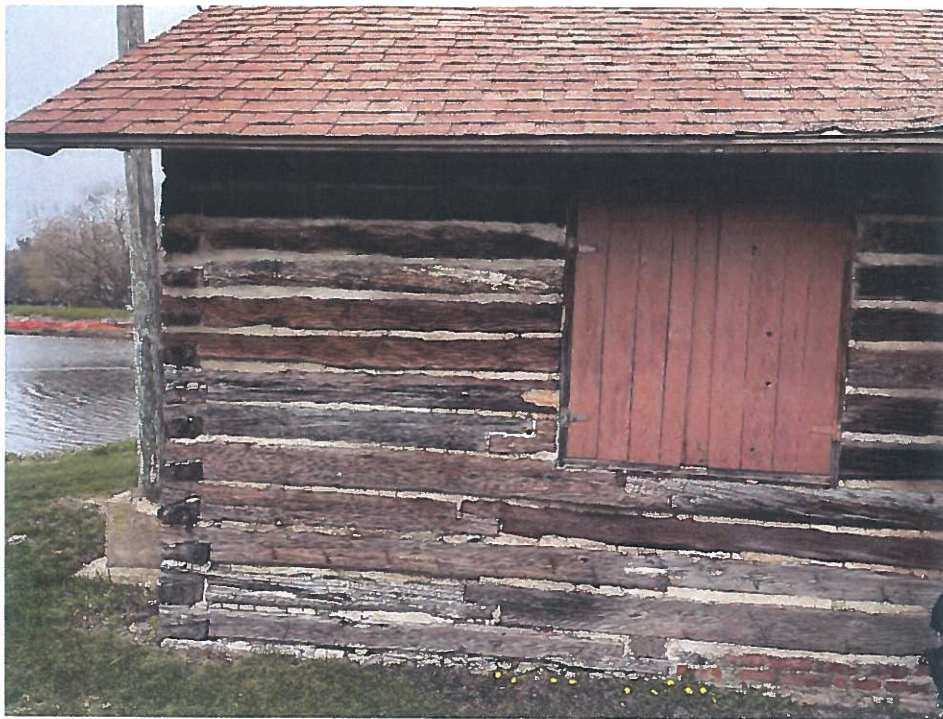
Figure 51. Partial North Elevation

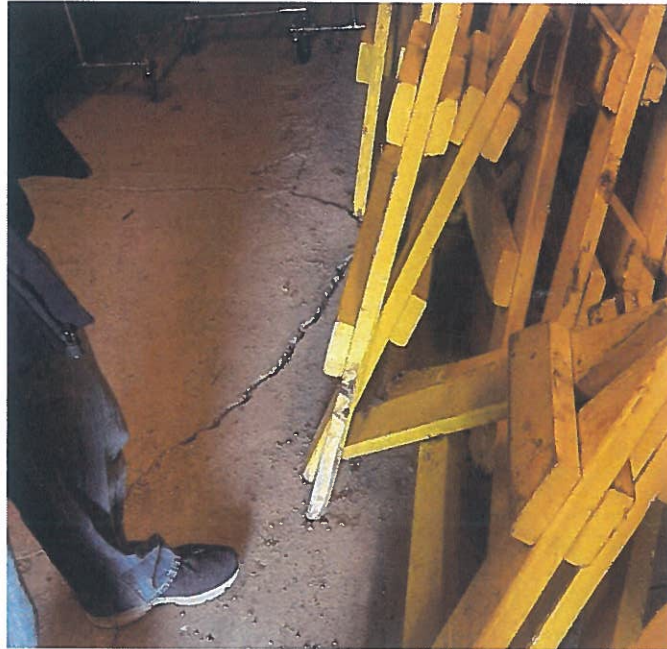
Figure 54. Concrete slab of the woodshop.

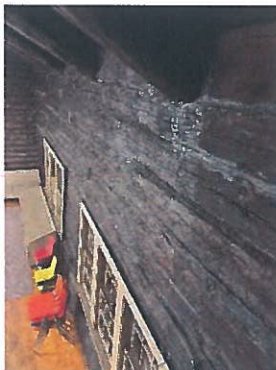
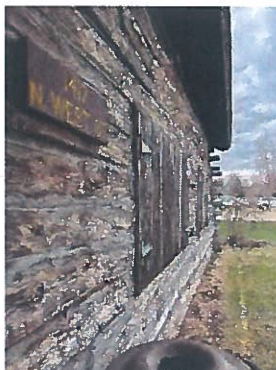
Girl Scout Log Cabin:

The cabin was reportedly constructed by Works Progress Administration (WPA) between 1935-1943 using traditional log construction techniques. Window openings are cut into the log construction interrupting the continuity of the logs. The plank roof construction sits over a series of log beams where every second beam is tied together with iron tie rods. The north elevation is engaged by a fireplace, stone chimney, and lean-to whereas the south elevation is long and unbraced with only a small lean-to porch at the main entrance. The east and west elevations are the short ends of the cabin. The south elevation is leaning outward by several inches but appears stable. There was no observed distress in the journey, logs or dawbing at joints between logs.

The conditions observed at the cabin do not pose a structural concern and the cabin can be used for public programs without immediate repair.

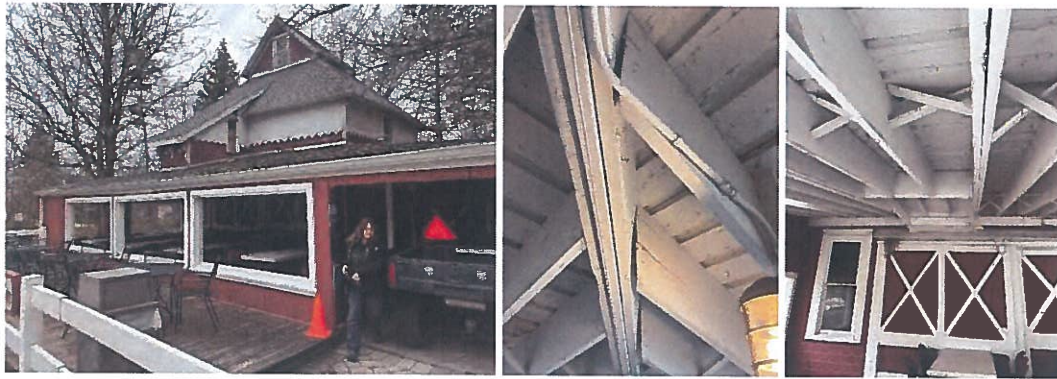
Cosley Zoo Taylor Barn:

The Taylor Barn was built more than 100 years ago and is understood to be the oldest existing barn in Wheaton. A lean-to structure was added to the barn c.1970 using standard 2x lumber construction and metal joist hangers. The walls and roof line are primarily plumb and true however, some of the nailed connections at the ridge rafters and framing below the hayloft chute are separating. Only the public picnic area located under the 1970's lean-to was reviewed as part of this visit.

To continue using the public picnic space until a detailed assessment and permanent repairs can be made, we recommend the following:

1. At the ridge rafter install **Simpson LSSR210Z adjustable rafter hangers** and rehang the separated joists to the ridge rafter.
2. Review opposite ridge rafter and joist connection for similar condition, if same separation exists, install same adjustable hangers.
3. Below hayloft chute near the middle of the roof, install **Simpson LUS210-Z hangers**.
